CUT EDGE CORROSION

Your guide to treating and repairing cut edge corrosion. Your solution to exterior metal roof and wall refurbishment.

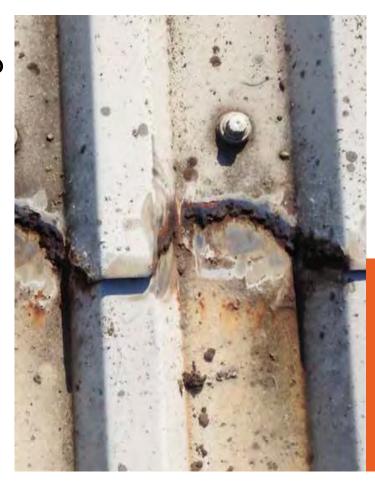
Cut edge corrosion describes the breakdown of the cut edge on metal cladding sheeting which, when exposed to the elements, causes peel back and deterioration.

Manufacture - When sheets are cut to size, this cut exposes a thin line of metal which isn't coated, thus not protected. The metal can also expand which causes the factory coating to lift, exposing the metal further. This can eventually lead to the whole coating delaminating which will make it very easy for the existing corrosion to eat through the metal completely.

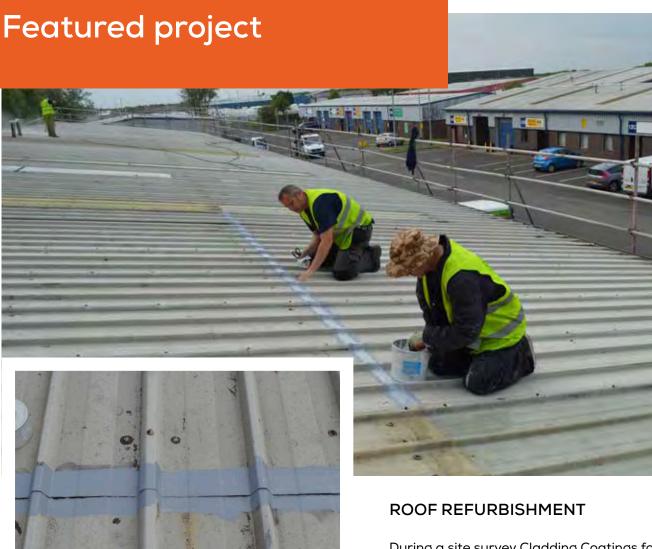
During a site survey Cladding Coatings found the warehouse units to be in need of some refurbishment with areas starting to corrode and painted cladding becoming flaky.

The process involved cleaning and drying the area, then using a hand held grinder to remove loose particles leaving a smooth debris free edge for the repair application to adhere to. A primer coat was then applied followed by a fibre tape to seal the edge, a top coat was finally applied to create a watertight seal of the cut edge.
