CUT EDGE CORROSION

Your guide to treating and repairing cut edge corrosion. Your solution to exterior metal roof and wall refurbishment.

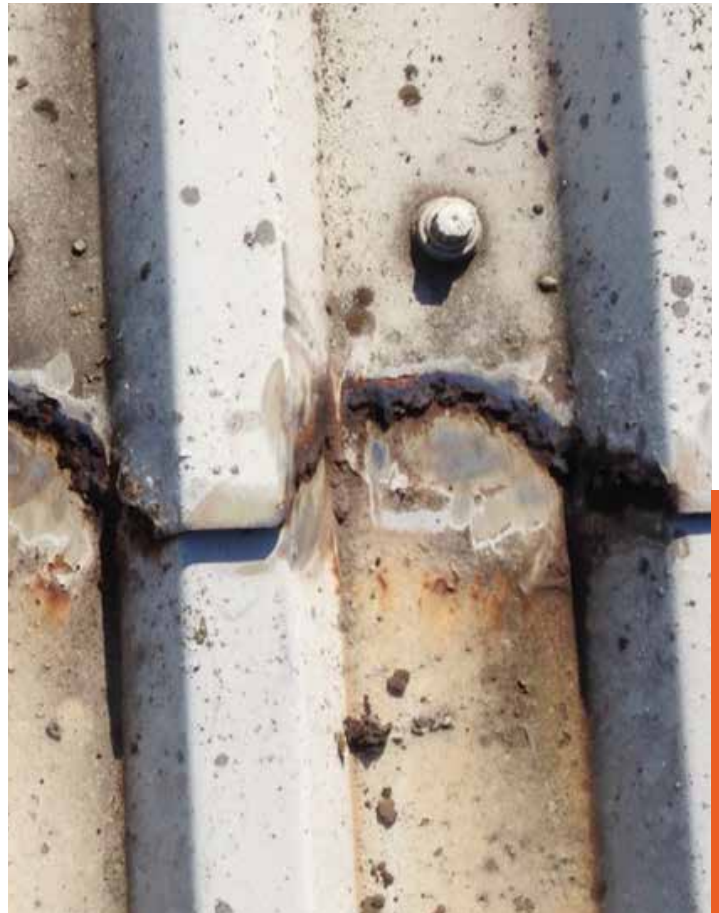
Cut edge corrosion describes the breakdown of the cut edge on metal cladding sheeting which, when exposed to the elements, causes peel back and deterioration.

Manufacture - When sheets are cut to size, this cut exposes a thin line of metal which isn't coated, thus not protected. The metal can also expand which causes the factory coating to lift, exposing the metal further. This can eventually lead to the whole coating delaminating which will make it very easy for the existing corrosion to eat through the metal completely.

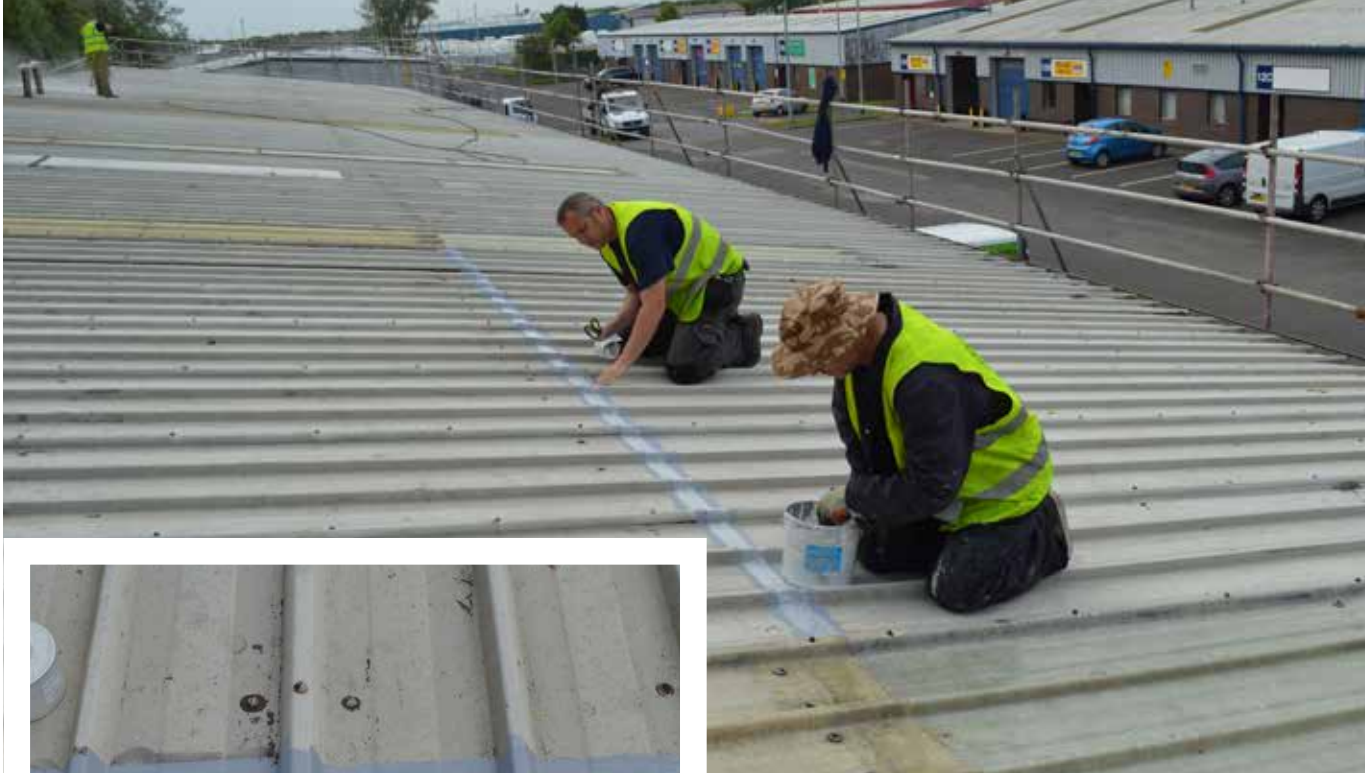
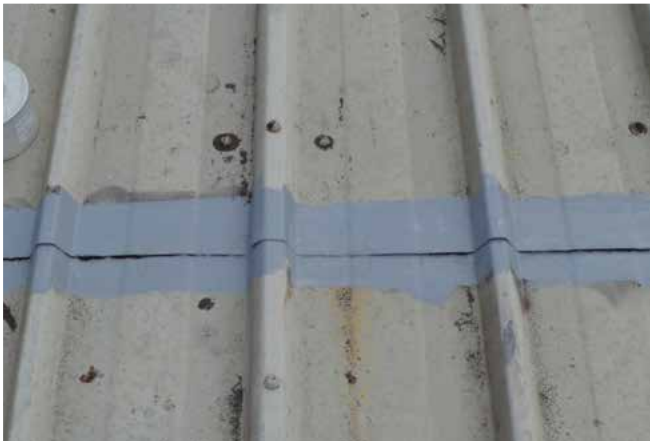
ROOF REFURBISHMENT

During a site survey Cladding Coatings found the warehouse units to be in need of some refurbishment with areas starting to corrode and painted cladding becoming flaky.

The process involved cleaning and drying the area, then using a hand held grinder to remove loose particles leaving a smooth debris free edge for the repair application to adhere to. A primer coat was then applied followed by a fibre tape to seal the edge, a top coat was finally applied to create a watertight seal of the cut edge.

The complete, repair and refurbishment of the 5 warehouse units, included all roofing, guttering & roof lights, walls & signage, windows & roller shutter doors.

We used Tor Coatings; Tor Elastaseal™ Fibretex which is an effective, durable flexible system.
